TECHNICAL SOLUTIONS FOR THE IMPROVEMENT OF LEVELISED COST OF WIND ENERGY OFFSHORE

The MAREWIND project, funded by Horizon 2020 program of the European Commission, addresses the main aspects related to the durability and maintenance of the different materials used in offshore wind power

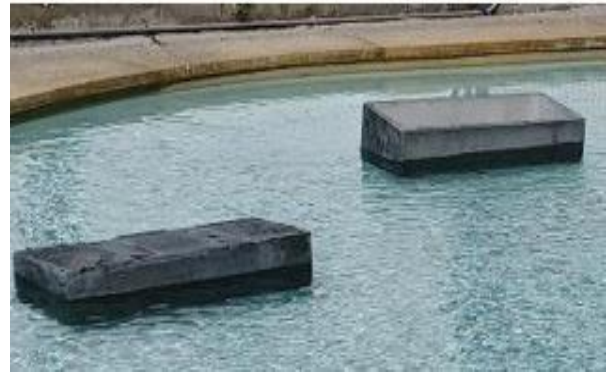
Ultra-High-Performance Concrete (UHPC) developed by ACCIONA presents 33% reduction in cement used compared to standard. Durability tests according to NT-492 showed after a year of exposure negligible corrosion rate ($k\Omega\cdot\text{cm}$) and extremely high chloride penetration resistance ($0.008\text{ m}^2/\text{s}$). Freeze and thaw resistance test reflected high durability performance at 200 cycles.

Fig.3. Small prototypes performed in preliminary trials to check production process and buoyancy.

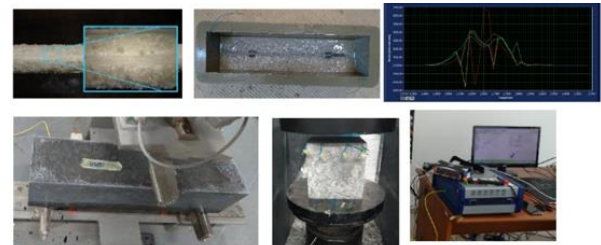
Regarding **Structural Health Monitoring** activities, on the one hand, integrated sensors have been successfully lab-scale demonstrated in concrete and blades.

Fig. 4. Acquired signal from SHM system inside UHPC concrete beam in different instants of loads.

- Successful testing of sensors on both concrete (ballast, foundations) and on composite-based blades for SHM.

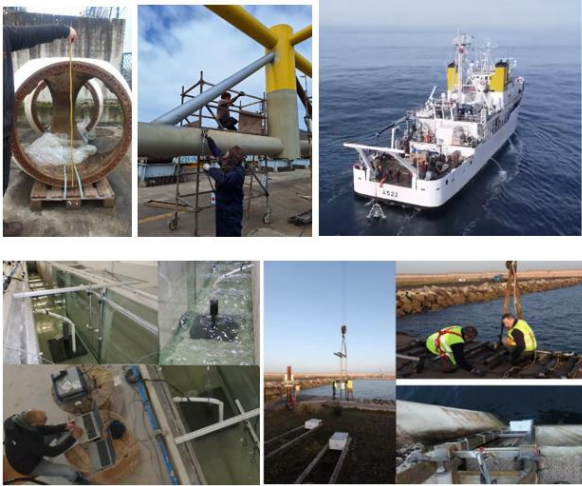
- Repair and maintenance activities on site for corrosion of metallic parts, leaded by KOSHKIL.
- Application of anticorrosion and antifouling coatings on Wind2Power floating platform from ENEROCEAN.
- Construction and deployment of a GBS structure immersed in the Sea by INEGI, including strain sensors, modified concrete ballast (AAM from CETMA) and antifouling coupons for real exposure testing.
- Wave channels tests started at EUMER with optimised concretes (UHPC and AAM) including fiber optic sensors for monitoring.
- UHPC prototypes have been installed by ACCIONA at Gijón Harbour for corrosion test performance at real environment.

Fig.6. Pictures of different demonstrative activities ongoing in the last year of MAREWIND project
