28th Annual Meeting of the European Musculo-Skeletal Oncology Society 16th EMSOS Nurse and Allied Professions Group Meeting

PP-004

A case of sacroiliac chondrosarcoma excision and spinopelvic reconstruction

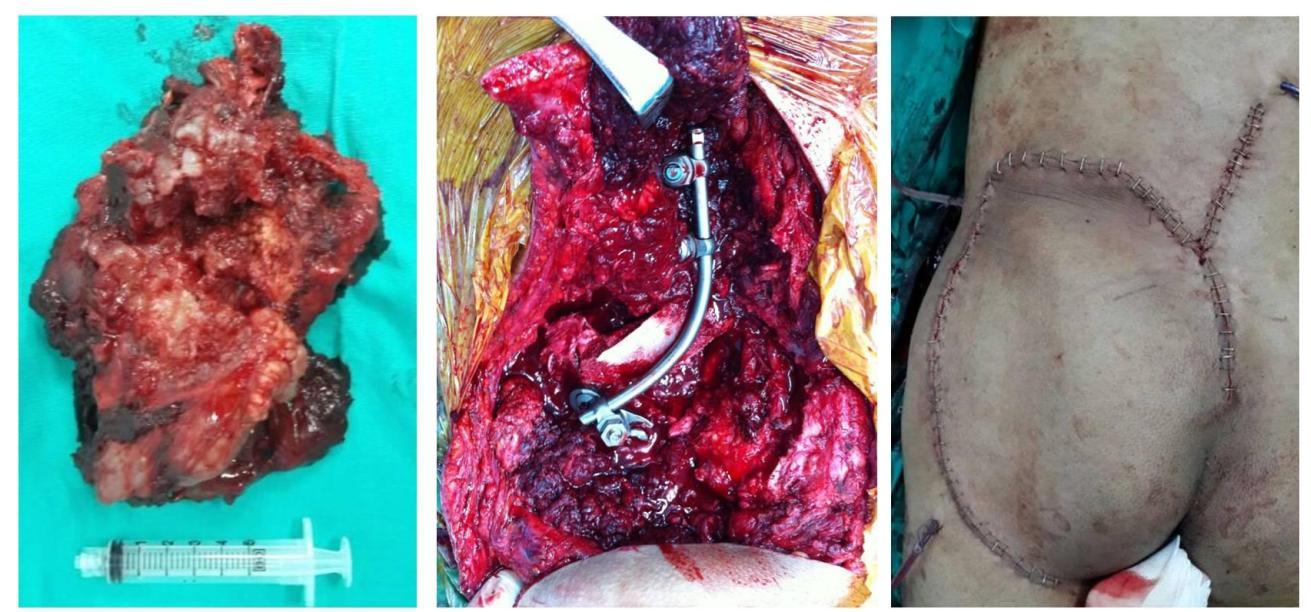
Figure 1. Intraoperative pics

Results: We performed an incisional biopsy and validated the histopathologic diagnosis. Partial sacrum, sacroiliac joint and juxtaarticular ilium excision was performed. Neural exploration was performed by two neurosurgeons. S1 root was intact. After bone and soft tissue resection, sacroiliac instability was observed. L4-L5 transpedicular screws and two iliac screws over an iliac plate were placed and connected with a rod. 6x3 cm autologous iliac crest graft was harvested ipsilaterally and inserted to the bone defect. Afterwards stability was achieved. Soft tissue defect was evaluated and reconstructed by two plastic surgeons utilizing a rotational gluteal flap.

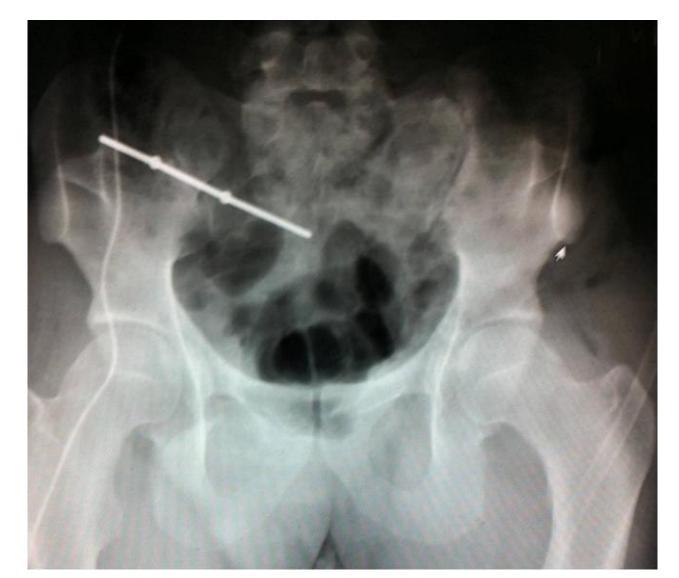
Figure 2. Intraoperative Xray

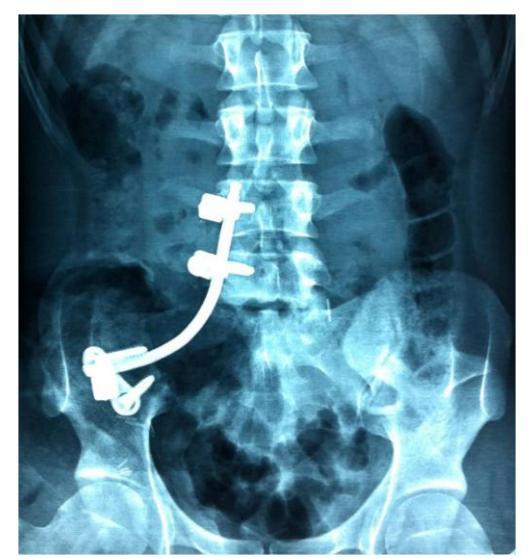
Figure 3. Postoperative Xray

Conclusions: Surgical resection of pelvic chondrosarcomas can be challenging because of the complex pelvic anatomy and the frequently large tumor size. After excision sacroiliac stability should be restored using proper instrumentation.
